WHOLE BUILDING PERFORMANCE ASSESSMENT

Sample Residence

Diagnostic Testing Results and Improvement Plan

December 27, 2009

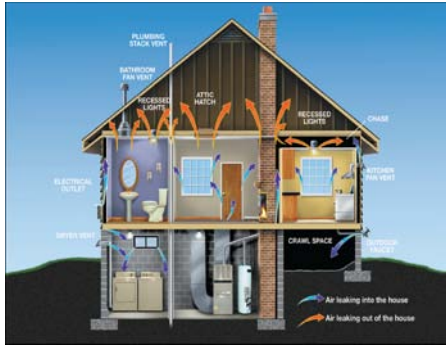
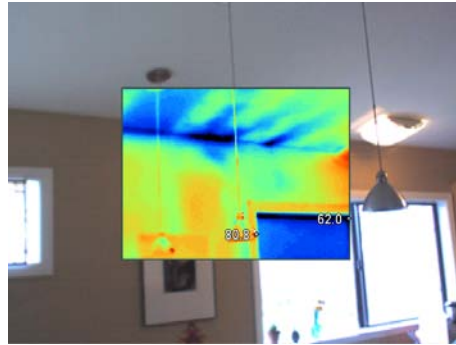
Air Infiltration

House air leakage was measured at 2,950 CFM₅₀ or 27% higher than building science performance standards

1. Un-sealed electrical, plumbing and mechanical penetrations from the crawl space and attic are pulling in outside air to the living area or leaking inside air out, depending on pressure differences
2. Baseboards leak air from the un-sealed crawl space areas
3. Top plates leak air from the un-sealed attic
4. The fireplace leaks air through the damper and the framed openings around the chimney
5. Air leakage occurs between the building material and the sliding glass doors

1. House
 - A. Seal window and door frames/trim to wall connections and baseboards to floor connections with interior latex clear caulking to reduce air infiltration.

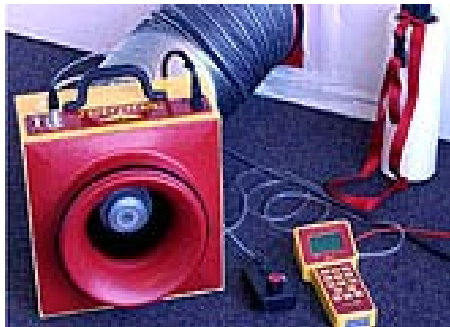
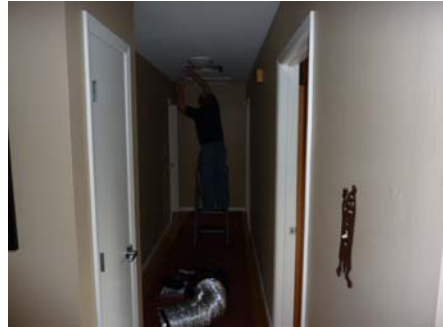
Duct Measurements

Furnace	1050 CFM
Duct Leakage	200 CFM ₂₅ or 23%
Supply Air (CFM)	Living Room
	West grill 95
	Center grill 78
	East grill 70
	Master bedroom
	West grill 69
	Master Bath 71
	Guest Bath 69
	Bedroom 2 70
	Bedroom 1 81
	Computer Room 98
	Kitchen Area 99
	Laundry Room <u>64</u>
Total	929

- E. Seal the existing ductwork, as feasible, or install new ductwork in accordance with ACCA Manual D Standards.
4. Lighting - Change out the remainder of incandescent light bulbs for florescent lighting or LED.

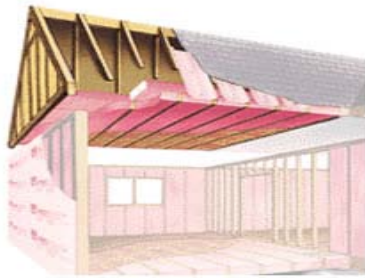
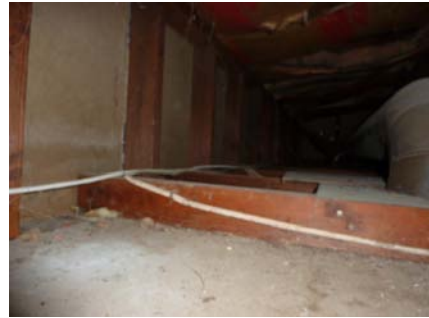
1. Attic insulation R-value is difficult to determine since it was not uniformly installed. The attic has fiberglass batt insulation that measures at the high point of approximately 4" equaling a "fair" R-value equivalent of 14
2. There are some areas in the attic that have displaced insulation or no insulation in the ceiling cavities

5. Attic - Hallway and bathroom areas
 - A. Seal all electrical, plumbing and mechanical penetrations.
 - B. Seal around the top plate areas, if accessible.

- C. Install blown-in cellulose insulation to a minimum value of R-38.
 - D. Weather-strip and insulate the attic hatch.
3. Crawl Space
 - A. Seal all sub-floor penetrations (electrical, plumbing and mechanical).

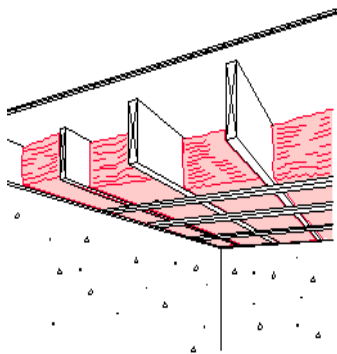
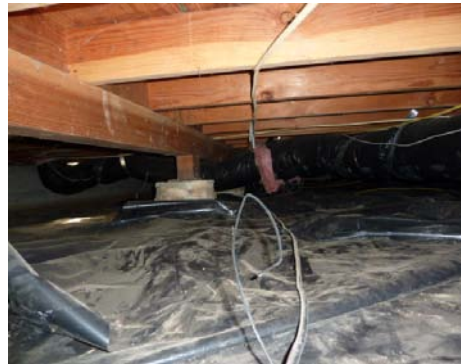
Floor

1. There is no insulation located between the floor joists
2. The hot water copper pipes are not insulated

- B. Seal other areas that are open to the conditioned space.
 - C. Install insulation on the hot water pipes.
 - D. Install floor joists insulation in each cavity.

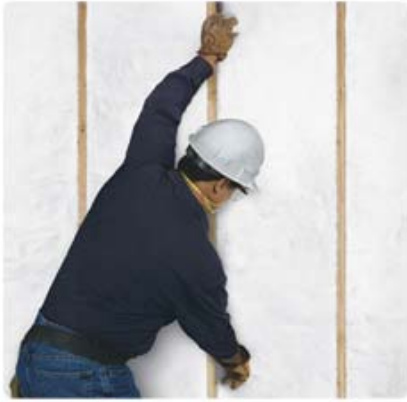
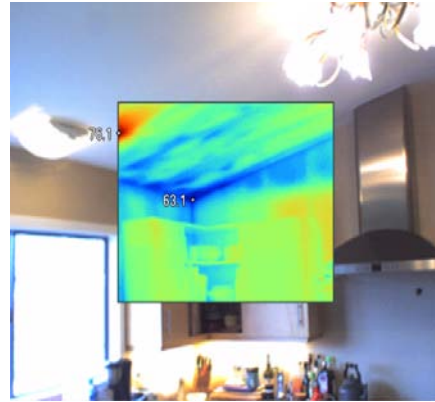
Walls

1. There are areas in the wall cavity that lack proper insulation
2. Some areas in the wall appear to be colder than other areas indicating the possibility of improperly installed insulation or no insulation

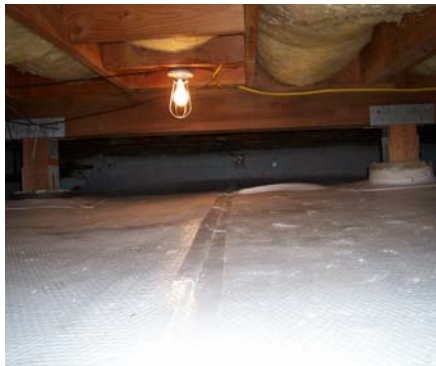
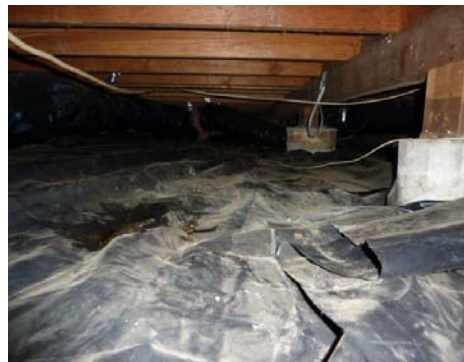
Crawl Space

1. There are no signs of water intrusion.
2. Un-sealed pipe, electrical and mechanical penetrations resulting in crawl space air entering into the living space through the floor assemblies.
3. There are no dampers on the supply ducts to regulate airflow.

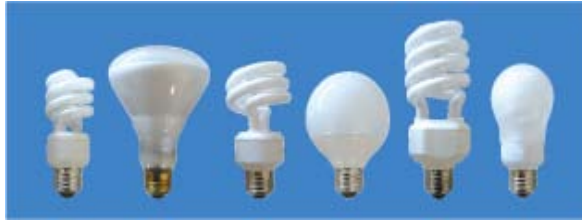
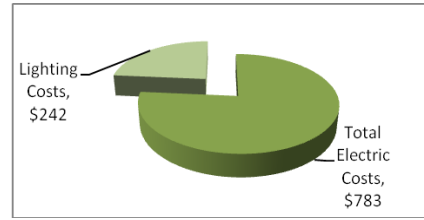
Lighting Efficiency

Lighting costs amount to approximately \$242 or 31% of total electric costs.

All lighting should be changed to fluorescence lamps. Saving lighting energy requires either reducing electricity consumed by the light source or reducing its on-time usage:

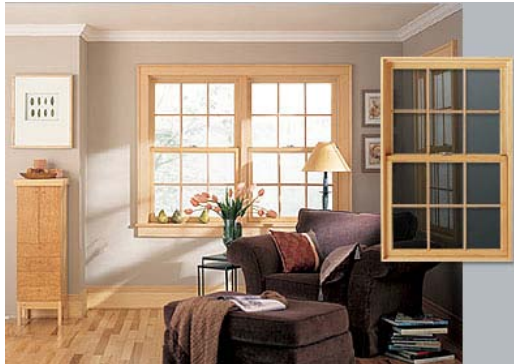
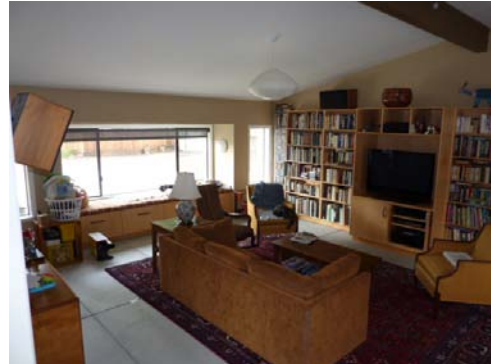
Windows & Sliding Doors

1. The windows are low-e clear, dual-pane with aluminum frames
2. The sliding glass doors are low-e clear, dual-pane glass with aluminum frames

Aluminum frame windows and doors remain the most conductive frame and are prone to condensation problems in winter months.

- E. Install energy efficient window coverings to prevent warm air converting to cold in the winter.
2. **Kitchen - The kitchen exhaust fan, when operating on the "high" mode is depressurizing the conditioned space and creating a safety condition if the combustion furnace back-drafts.**

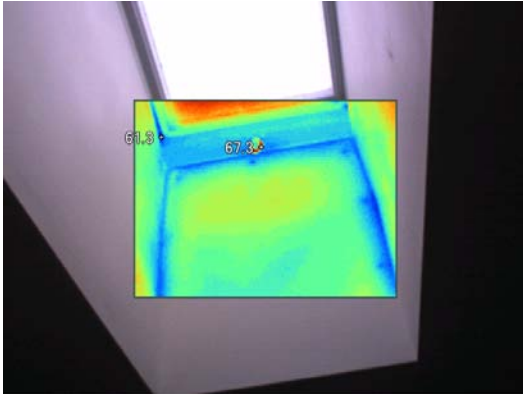
Cold skylight area

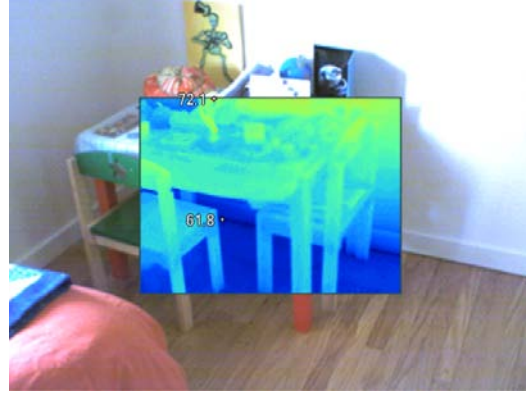
Cold bottom-plate floor area

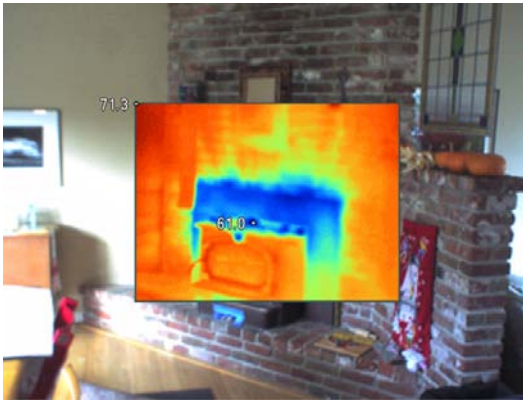
Cold fireplace damper area

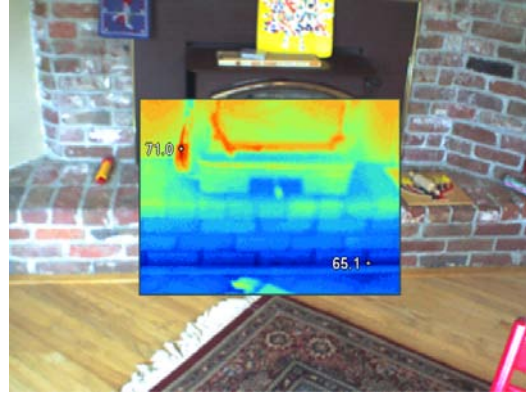
Cold floor area

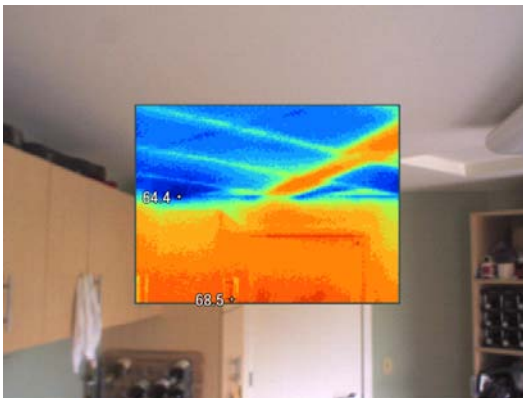
Cold ceiling area

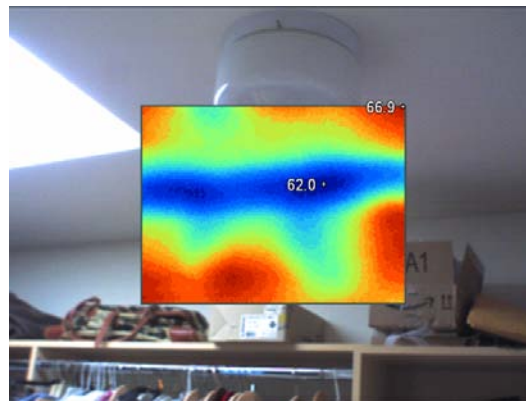
Cold top-plate area
