WHOLE HOUSE PERFORMANCE ASSESSMENT

Sample Residence

Diagnostic Testing Results and Improvement Plan

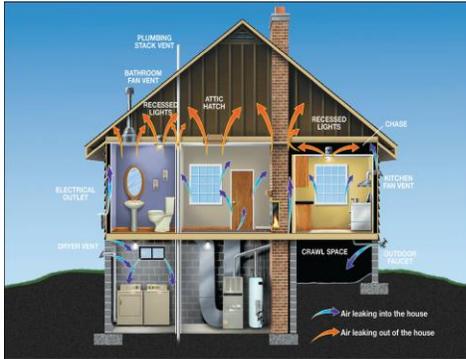
Air infiltration areas

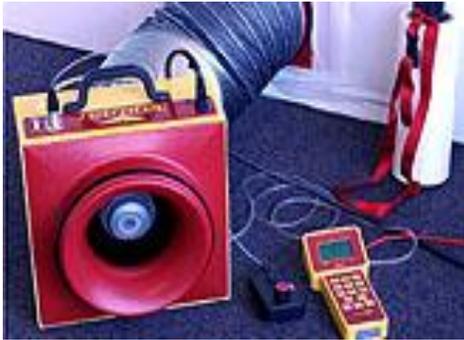
Duct tester and manometer

There are 2 options to reduce duct leakage: air-seal the areas of leakage or replace the duct system with one that is sized, air-sealed and insulated properly. Duct leakage should be $\leq 5\%$.

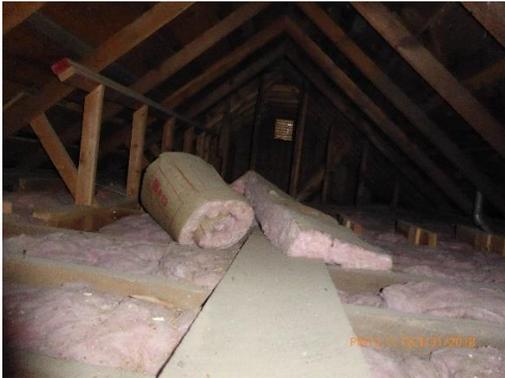
Attic insulation of R-19 value with insulation not properly installed.

1. Attic Areas
 - A. Air-seal all electrical, mechanical and plumbing penetrations and openings (that are accessible) to the living space.
 - B. Install rulers every 250 Ft. and blow-in fiberglass insulation to total approx. 14" ($\geq R-50$).

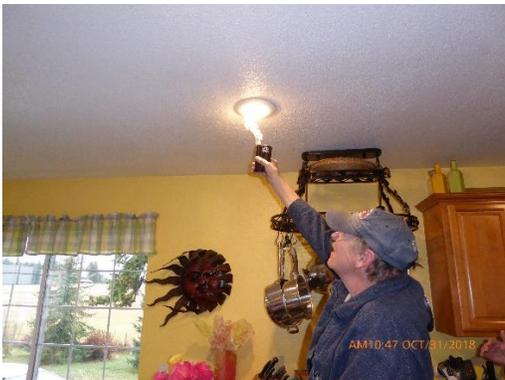
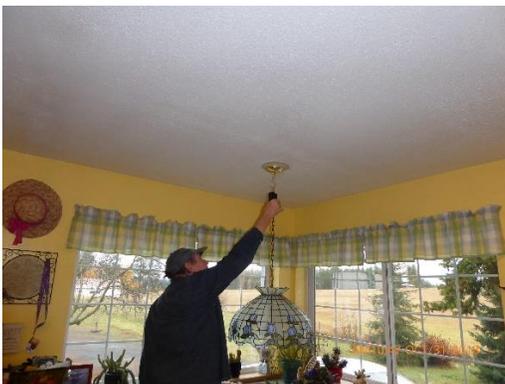
Smoke being sucked into the ceiling assembly thru the can light fixture.

Same as above.

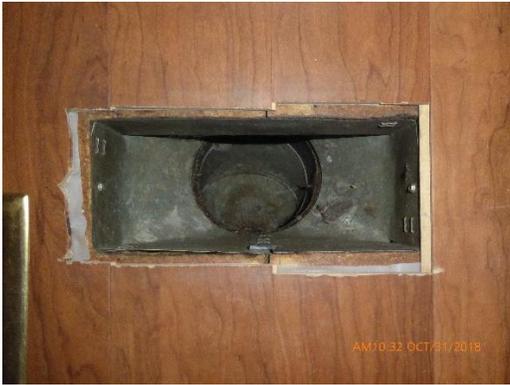
Supply air boot not air-sealed to the building material.

- B. The unsealed sheet metal boots.
 - C. The unsealed propane gas line opening.
2. Furnace operates on fuel oil and is a forced air system with a capacity sized at 96,000 BTU. It is 80% energy efficient.

- B. Replace and enlarge supply air main, branches, boots and return air main, branches and boots.
 - C. Insulate all ductwork where accessible.
 - D. Install additional properly sized return air ductwork throughout the house where feasible.

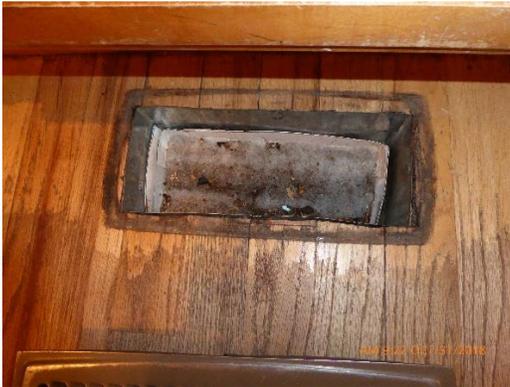
Supply air filter in openings restrict delivered air flow.

- E. Replace supply air registers to allow for more delivered air into the living space.
 - F. Cut larger openings in the existing 2 return air locations.

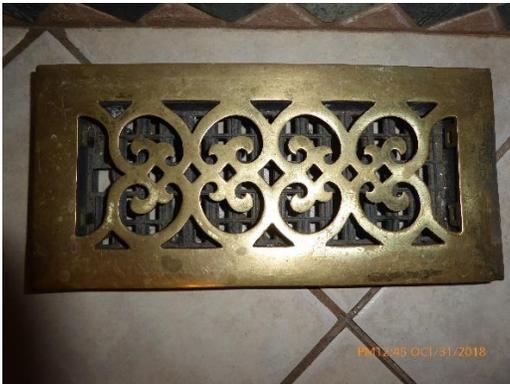
Supply air register restricts delivered air flow.

- E. The supply air registers are too restrictive for proper delivered air flow.
3. Lighting is incandescent, fluorescent and LED.

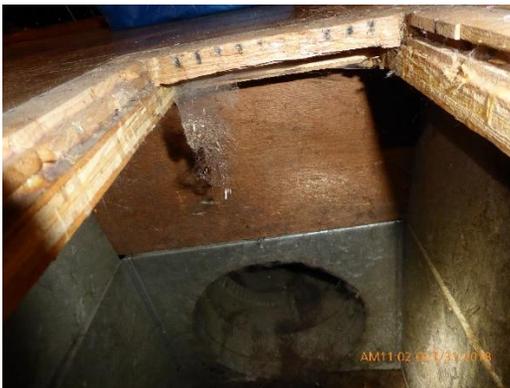
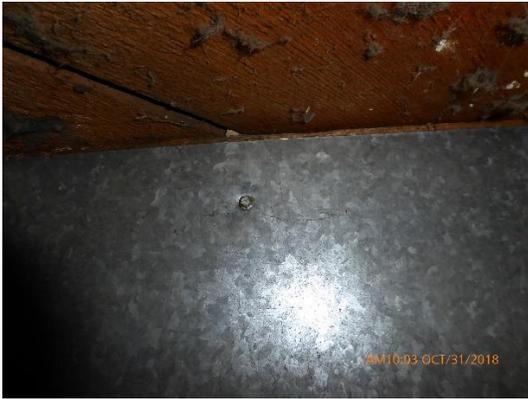
Return air opening is too small for the sheet metal duct.

Same as above on second return air opening.

- C. The return air main and branches too small for the capacity of the furnace.
 - D. The supply air boots and return air openings are not air sealed to the building material.

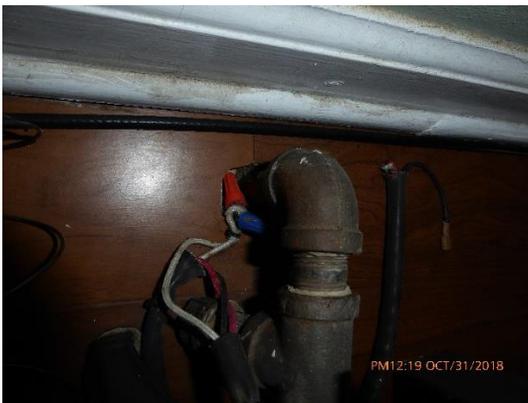
The hole on the floor is too large for the propane gas line. It needs to be air-sealed.

Air-seal all electrical, mechanical and plumbing penetrations that lead into the living space.

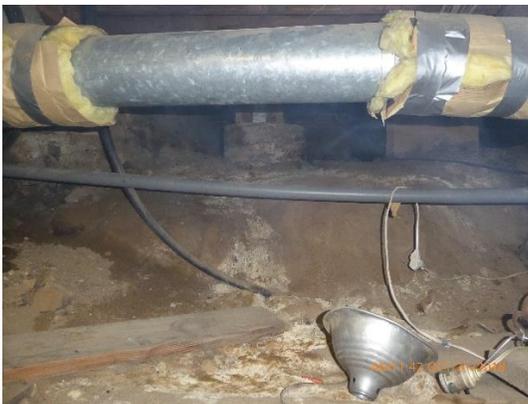
Partially insulated ductwork.

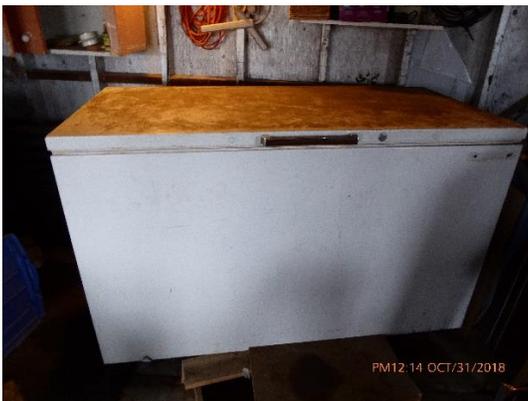
The freezer, located in the garage, is over 40 years old and is not energy efficient.

- B. Install R-19 value floor insulation where accessible.
5. Insulate exterior walls that have no insulation.
6. Replace old freezer with one that is energy efficient.
